SADDLE LAKE DAM

NDS No. PA-00895
DER No. 66-56

WYOMING COUNTY, PENNSYLVANIA

**PHASE I INSPECTION REPORT
NATIONAL DAM INSPECTION PROGRAM**

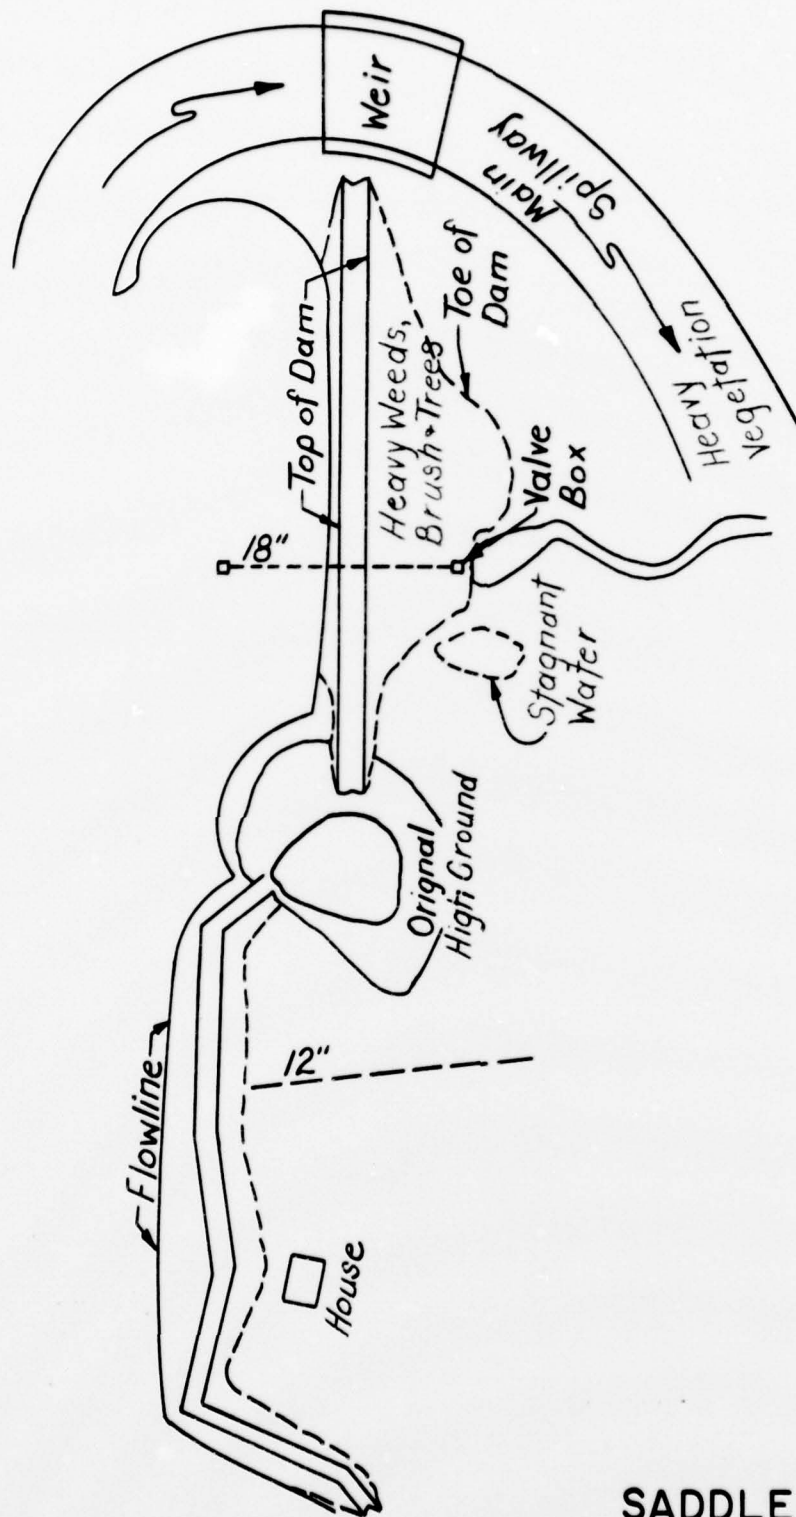
PLATE A-I

C. SLOUGHING OR EROSION OF EMBANKMENT OR ABUTMENT SLOPES	None detectable - cover too thick to observe slope conditions.
D. ALIGNMENT OF CREST: HORIZONTAL: VERTICAL:	Horizontal appears good. Vertical - see Plate A-II, Appendix A.

SADDLE LAKE DAM
PA.895
INSPECTION SURVEY

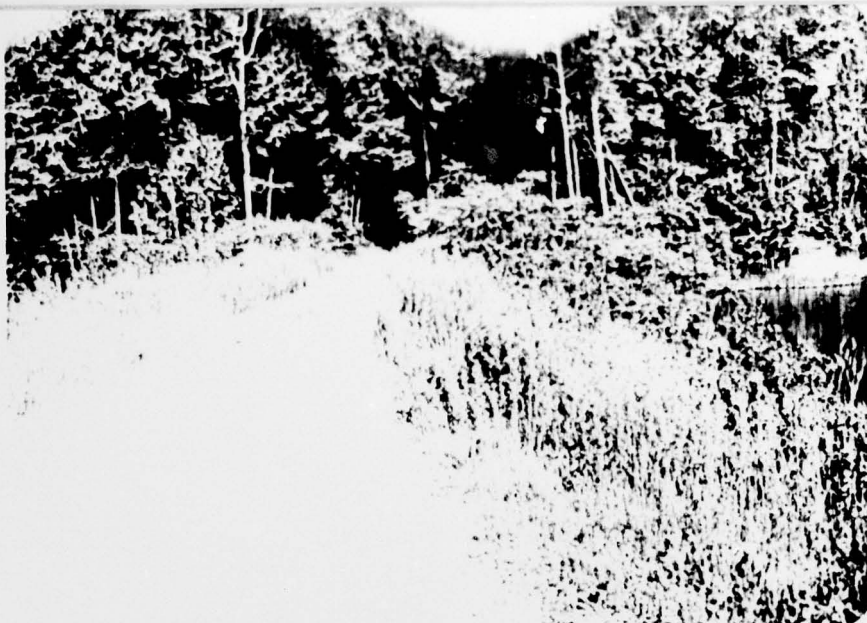
The top of the embankment is partially covered by the deteriorated remains of a bituminous paved surface. The field measured slope ratios are 2.76H to 1V upstream and 2.85H to 1V downstream as compared to 3H to 1V for both slopes on the design drawings.

Top of Dam
and
Upstream Slope

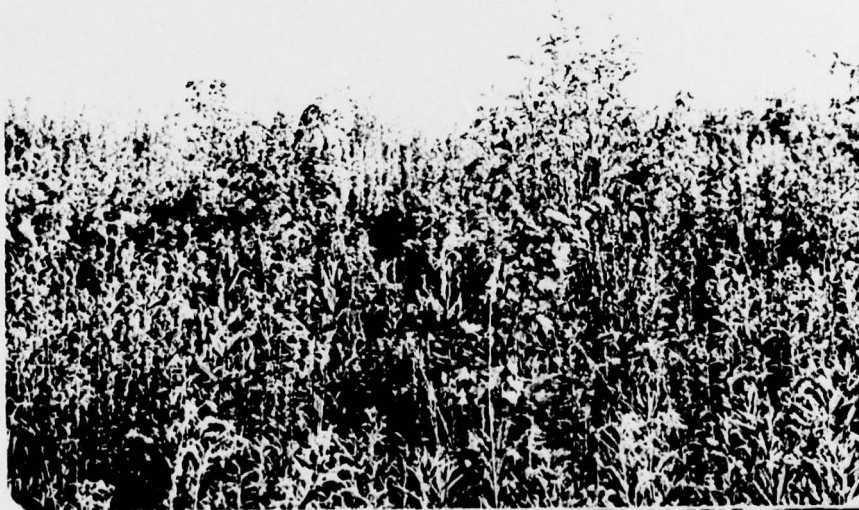
The heavy growth on the embankment slopes did not permit close inspection of the slope surfaces. This condition applies to both sections of the embankment on either side of the knoll.

Downstream Slope
with Brush

1. That the trees, brush, and weeds be removed from the embankment slopes and to ten feet downstream from the toe of the embankment and that a close inspection of the slope surface be made at that time.
2. That the trees, brush and weeds be removed from the spillway outlet channel and stilling basin.
3. That the wet condition located to the right of the outlet structure be examined after removal of trees, brush and weeds to identify its source and that regular observations be made noting flow and clarity. If changes are noticed take immediate steps to correct the condition.
4. That a means for providing an upstream closure control on the intake structure be developed and installed.

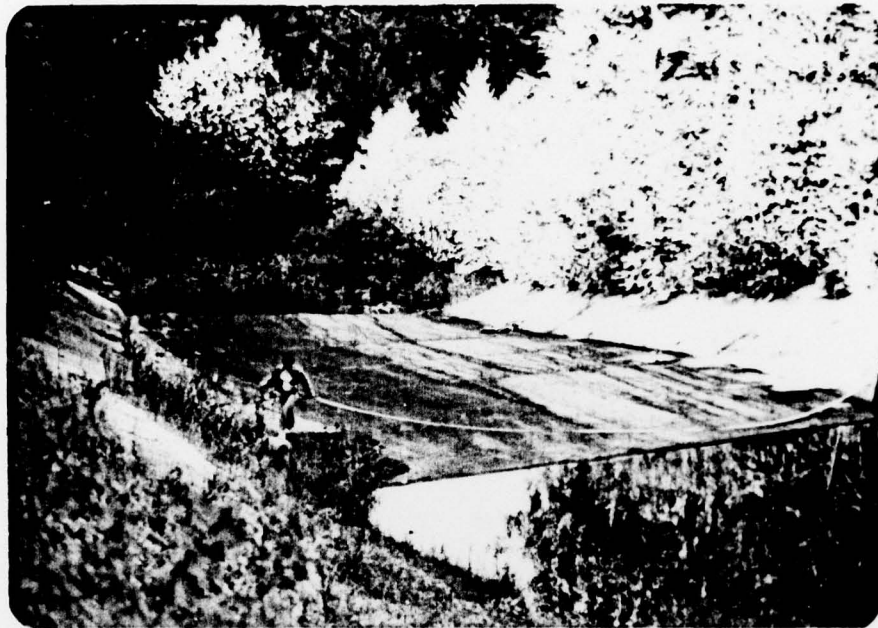
The spillway and its outlet slab and sloped walls did not show any serious deterioration or cracks. The outlet slab slopes gently to its terminus 57 feet downstream from the crest of the spillway. The spillway outlet channel continues beyond the concrete and is paved with riprap, including the side slopes to a stilling basin approximately 250

feet downstream. The riprapped portion of this channel and the stilling basin is grown over with a dense cover of brush and small trees. As a result, the condition of the channel could not be determined by visual inspection.

Spillway & Overgrown Discharge Channel

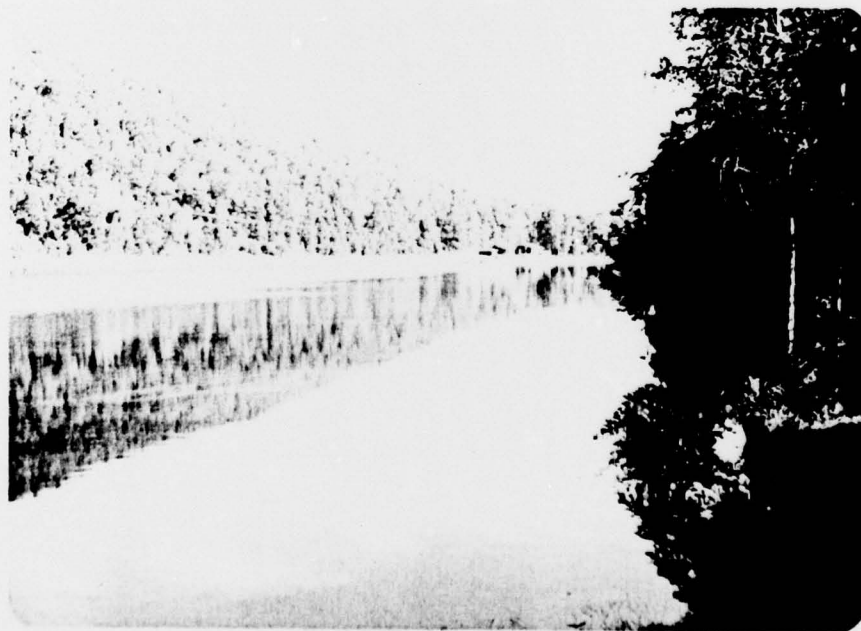
Reservoir
